Date Delivered September 08, 2017 10:48AM
Strata Manager Assertive Northwest Property Management Group Inc.
eStrataHub Order Number 191192
Folio Reference 1401-114 W Keit
Requestor Company Remax
Requested By Jim Williamson
Property Name Ashby House
Strata Plan # VAS145
Strata Lot # 45
Civic Address 1401-114 KEITH ROAD

eSH191192-03-Depreciation Report_VR-0145 - Depreciation Report FINAL(133).pdf

Document: Warranty
Property: Ashby House
Strata Plan #: VAS145
Strata Lot #: 45
Comment: The document you requested is not available for this property.

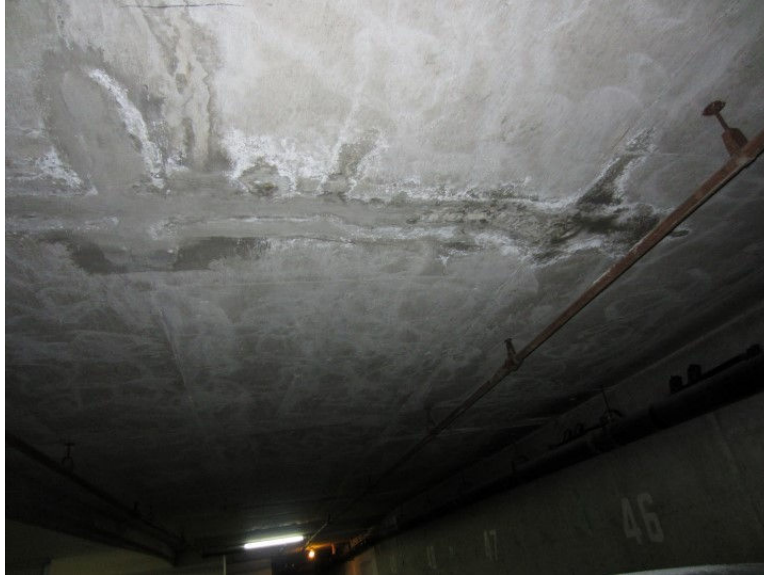
Image 1. Repair Crack Actively Leaking

Unit Quantity	1 Building								
Unit Cost Estimate	\$5,000								
Current Repair or Replacement Cost Estimate	\$5,000 (Allowance)								
Estimated Year of Major Repair or Replacement	2019								
Additional Comments	<p>An allowance has been chosen to cover the cost of materials. Please advise the planner if the Council would like the pricing of epoxy injections rather than the continuous repairs currently being undertaken.</p>

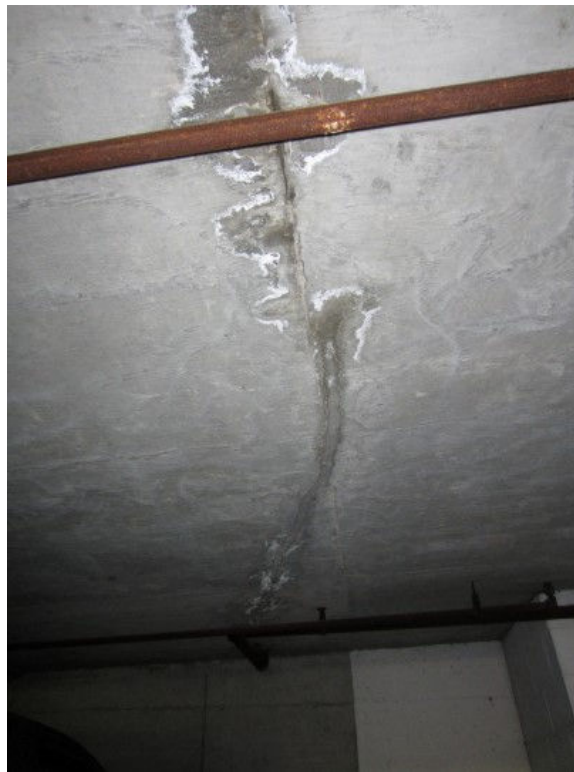
Image 2. Crack in Ceiling

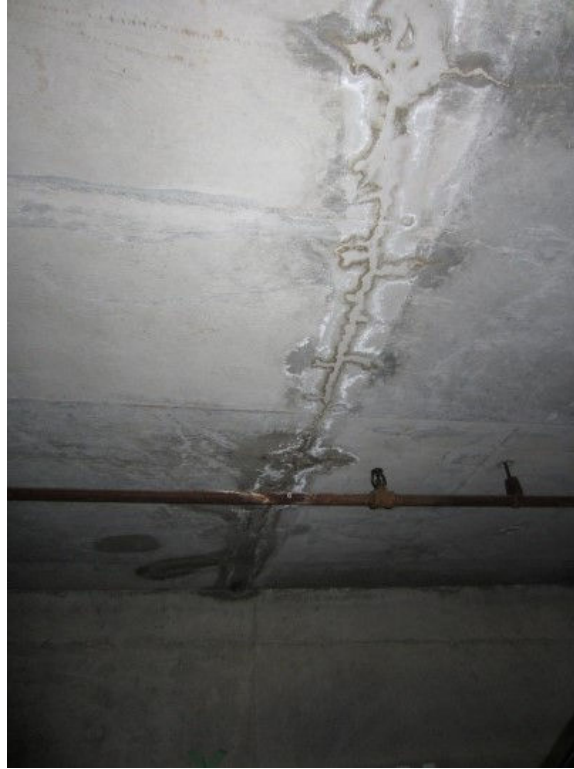
Image 3. Crack in Ceiling

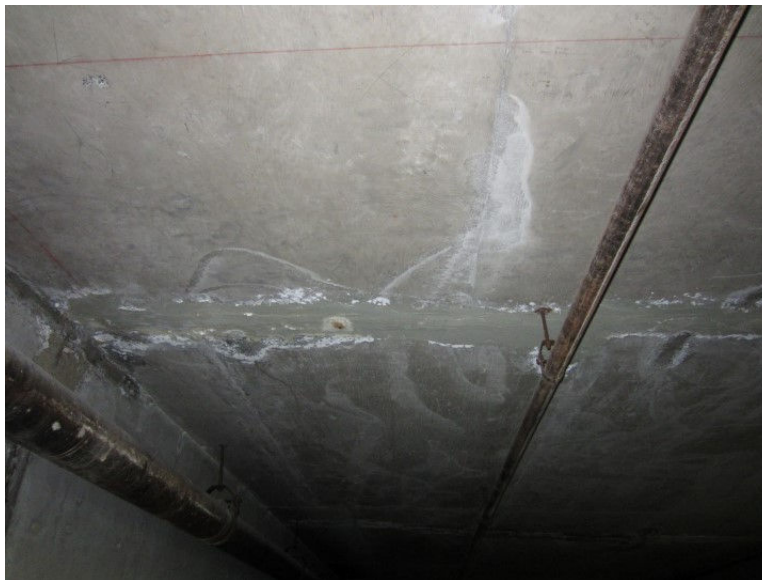
Image 4. Repaired Crack in Ceiling

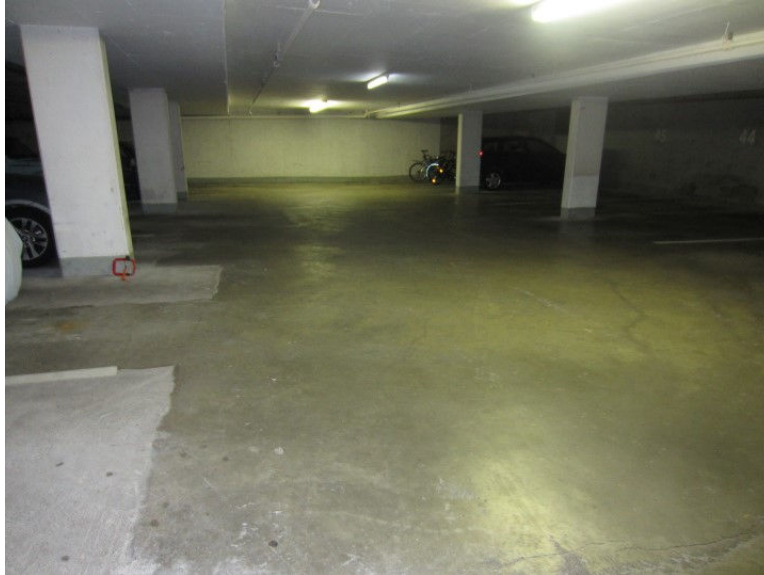
Date of Acquisition	1974								
Normal Life Span	15 years								
Effective Age	5 years								
Remaining Life Span	10 years								
Unit Quantity And Cost Estimates	<table border="0"> <tr> <td>Unit Quantity</td> <td>10,950 ft²</td> </tr> <tr> <td>Unit Cost Estimate</td> <td>\$10,500</td> </tr> <tr> <td>Current Repair or Replacement Cost Estimate</td> <td>\$10,500 (Allowance)</td> </tr> <tr> <td>Estimated Year of Major Repair or Replacement</td> <td>2024</td> </tr> </table>	Unit Quantity	10,950 ft ²	Unit Cost Estimate	\$10,500	Current Repair or Replacement Cost Estimate	\$10,500 (Allowance)	Estimated Year of Major Repair or Replacement	2024
Unit Quantity	10,950 ft ²								
Unit Cost Estimate	\$10,500								
Current Repair or Replacement Cost Estimate	\$10,500 (Allowance)								
Estimated Year of Major Repair or Replacement	2024								
Additional Comments	<p>An allowance has been chosen due to the square foot price of traffic coating and the per stall price of the line painting.</p> <p>The traffic coating is in good condition with little signs of wear. Strata has done a great job maintaining its condition and therefore no deficiencies were noted.</p>

Image 5. Garage Sealant

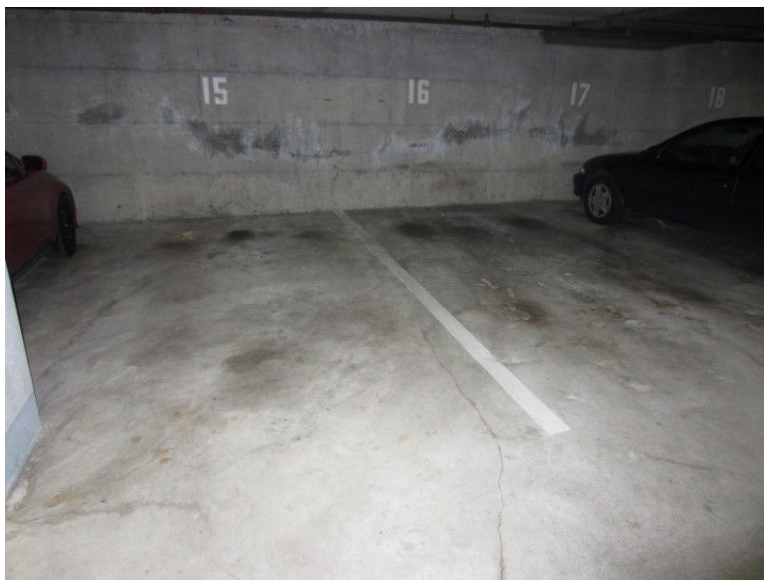
Image 8. Example of Parking Line's Condition

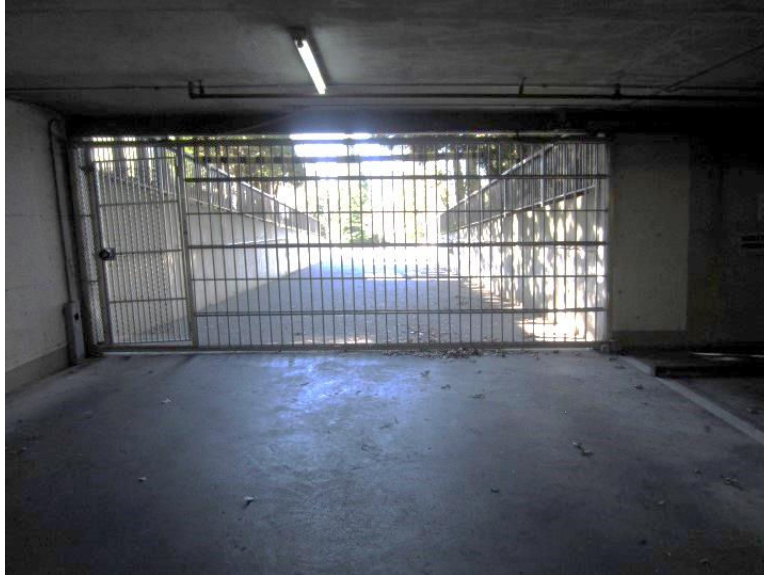
Unit Quantity	2 Units								
Unit Cost Estimate	\$7,500 /unit								
Current Repair or Replacement Cost Estimate	\$15,000								
Estimated Year of Major Repair or Replacement	2021								
Additional Comments	<p>No deficiencies noted.</p> <p>The expenditure in 2021 has been split into 2 years to allow Strata to repair/replace door components as needed. This will allow Strata to take a phased approach and repair on an "as needed" basis.</p>

Image 9. Slide Garage Door

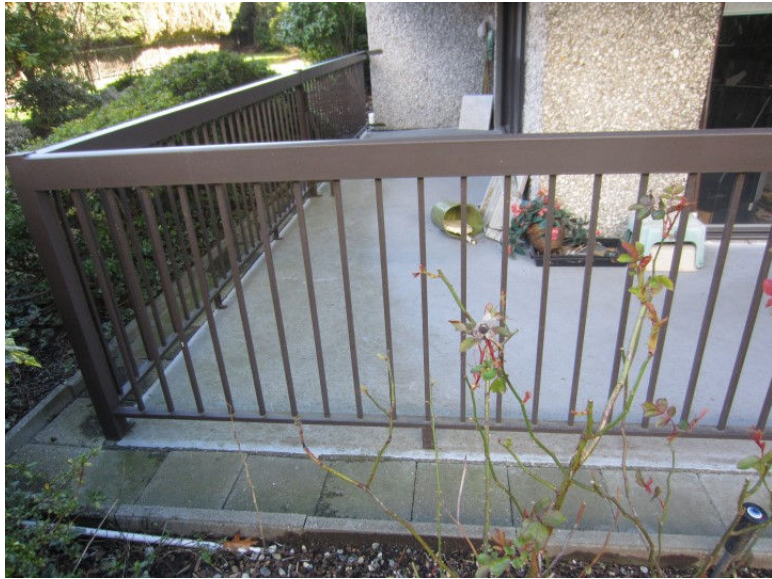
Condition Analysis	<p>The balconies are in good, clean condition. Two balconies were inspected and it is assumed that the conditions of the balconies, not inspected, are in similar condition.</p>	
Life Cycle Analysis	Date of Acquisition	1974
	Normal Life Span	15 years
	Effective Age	1 years
	Remaining Life Span	14 years
Unit Quantity And Cost Estimates	Unit Quantity	10,360 ft ²
	Unit Cost Estimate	\$65,000
	Current Repair or Replacement Cost Estimate	\$65,000 (Allowance)
	Estimated Year of Major Repair or Replacement	2028
Additional Comments	<p>Painted concrete balconies can be gently washed to eliminate algae growth or discolouring. No deficiencies noted.</p>

Image 11. Typical Painted Concrete

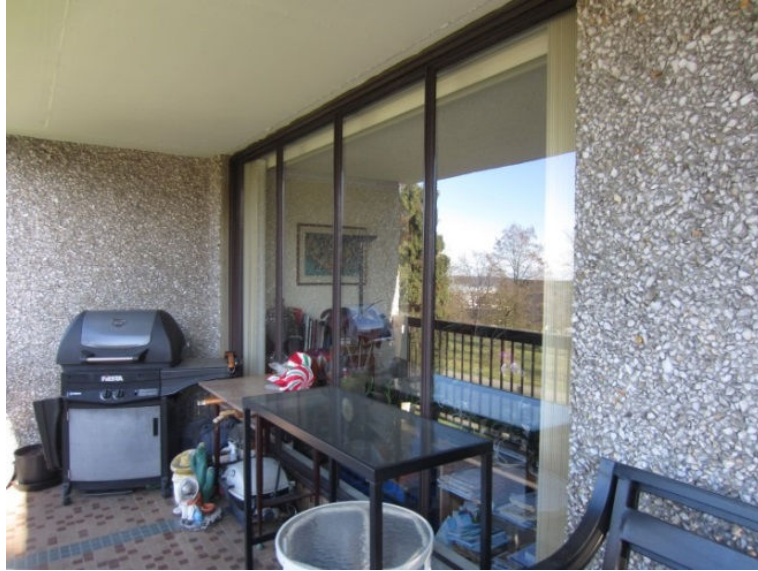
Normal Life Span	40 years
	Effective Age	32 years
	Remaining Life Span	8 years
Unit Quantity And Cost Estimates	Unit Quantity	6,050 ft ²
	Unit Cost Estimate	\$565,000
	Current Repair or Replacement Cost Estimate	\$565,000 (Allowance)
	Estimated Year of Major Repair or Replacement	2022
Additional Comments	<p>The window replacement 2022 has been pushed back to 2026 and split into a 2 year project. This is to allow the Strata to take a phased approach at replacement and allowing more time to accumulate appropriate funds.</p>

Image 13. Casement Windows

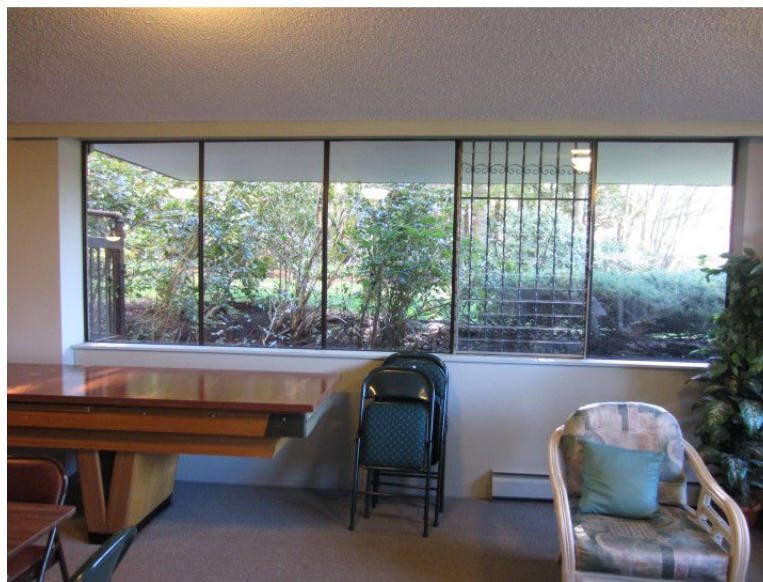
Image 14. Social Room Window with Shutter Openers

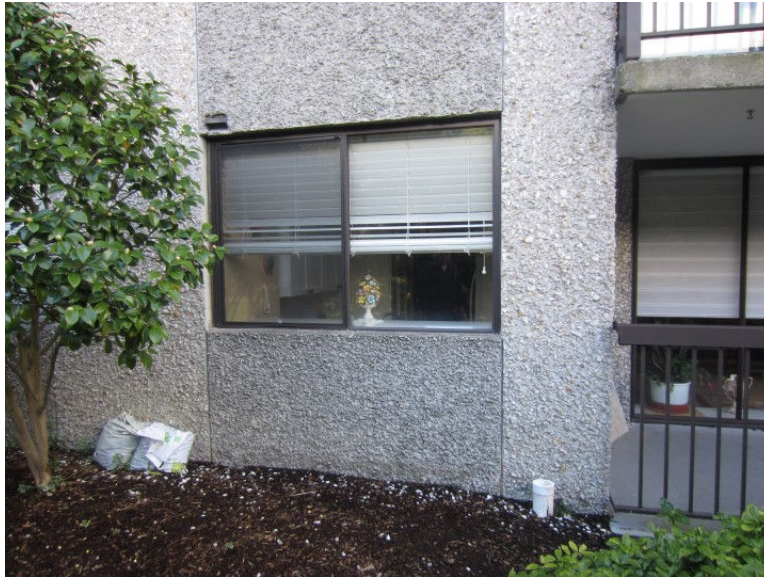
Image 15. Sliding Glass Window

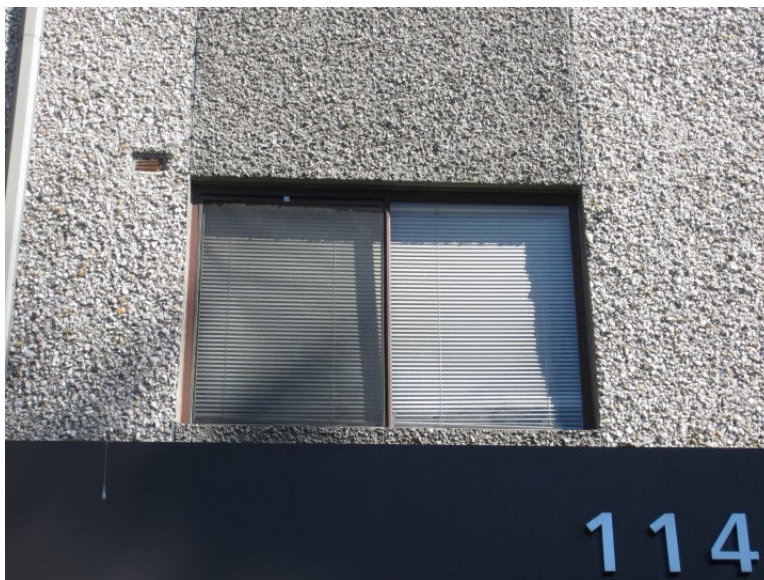
Image 16. Typical Sliding Glass Window

The windows and sliding glass doors are all original to the building and will need to be replaced. The Strata has recently undergone a re-pipe project which replaced the floor's lateral piping, this did not include the risers which will need to be replaced in the next few years. The underground garage membrane will need to be investigated and possibly remediated. The report currently has a small expenditure in 2016 which will allow Strata to conduct an investigative report to determine the condition of this membrane. In the underground garage there is an area actively leaking water which signals a membrane problem and may foreshadow future problems. Once a quote, and remediation plan, is decided upon the report can be amended to reflect a more precise process. As the building is reaching 40 years old many major building components are beginning to see the end of their useful life. Although these projects can be pushed back, the longer Strata waits to replace, or renew, the more dated the building may appear compared with surrounding properties.

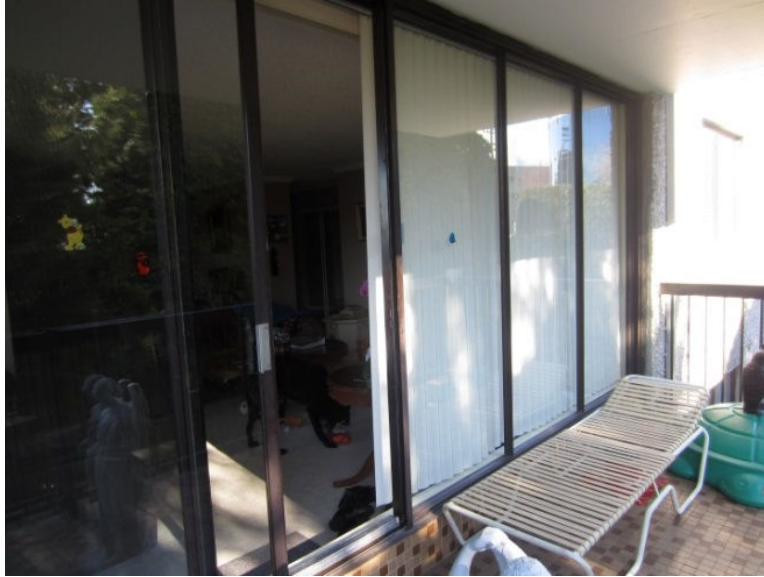
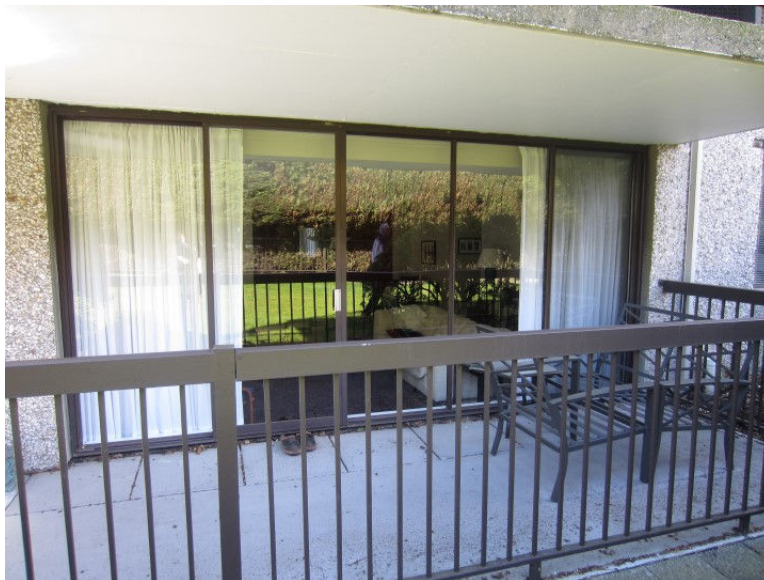
Image 17. Sliding Glass Patio Door

Image 18. Sliding Glass Patio Door

Estimated Year of Major Repair or Replacement	2021
Additional Comments	<p>When it becomes time to replace the windows and balcony doors, a combined replacement should be considered. This will significantly decrease the labour price associated with scaffolding, access, and city permits.</p> <p>The expenditure in 2021 has been split up over two years and pushed back, to correspond with the work scheduled, to begin in 2023.</p>

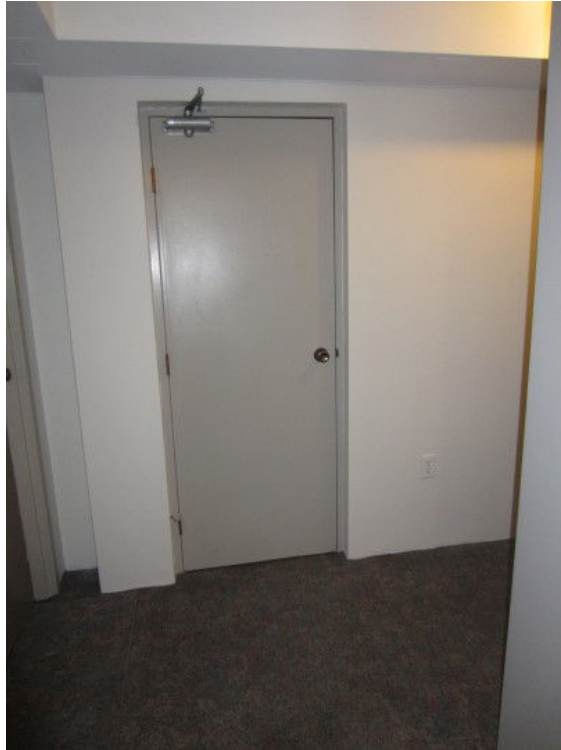
Image 19. Exit Door

Physical Description	<p>Exit and service doors are, A Grade steel fire doors, rated for 1 ½ hr. fire resistance. Stairwells exiting into the parking garage include a steel store front assembly with polished wired glass.</p> <p>This reserve component includes the replacement of the door, frame, and hardware.</p>	
Financial Analysis	<p>Doors are original to the building and no known expenditures have been made</p>	
Potential Deterioration	<p>Deterioration can include</p> <ul style="list-style-type: none"> • Scratching • Wear and tear, misuse and vandalism • Weathering from outdoor exposure 	
Condition Analysis	<p>All doors are functioning properly, with no major problems detected. The doors, and door frames, have been painted and no significant damage was noted.</p>	
Life Cycle Analysis	Date of Acquisition	1974
	Normal Life Span	30 years
	Effective Age	13 years
	Remaining Life Span	17 years
Unit Quantity And Cost Estimates	Unit Quantity	4 Doors

Unit Cost Estimate	\$5,500
	Current Repair or Replacement Cost Estimate	\$5,500 (Allowance)
	Estimated Year of Major Repair or Replacement	2031
Additional Comments	<p>It is not considered practical to replace all service, exit or suite doors in a coordinated program, as the wear and tear on the doors does not generally necessitate complete replacement. An allowance of \$5,500 has been allotted to allow for replacement of 4 doors, over 30 years.</p>

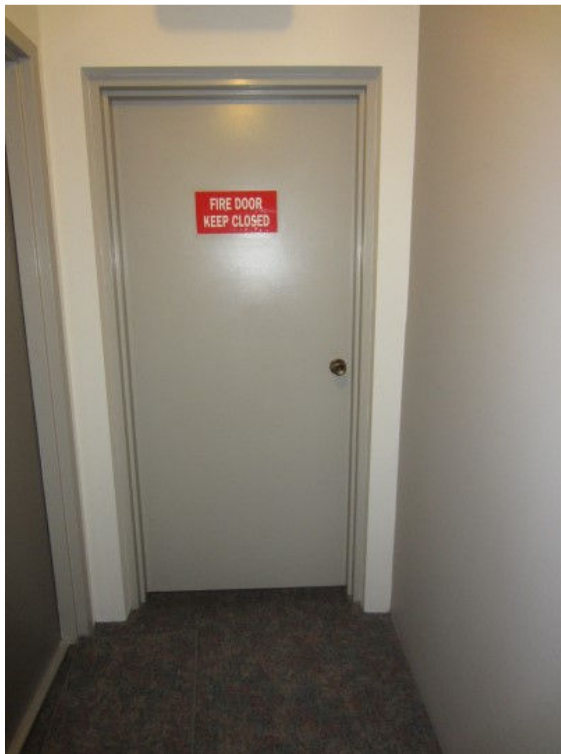
Image 20. Exit, Fire Rated Doors

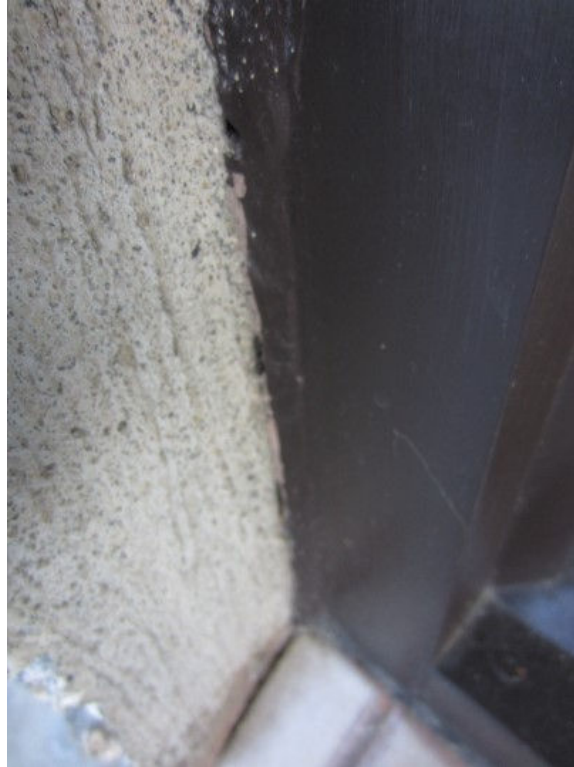
Image 21. Window Caulking

Unit Cost Estimate	\$32,000
	Current Repair or Replacement Cost Estimate	\$32,000 (Allowance)
	Estimated Year of Major Repair or Replacement	2019
Additional Comments	<p>In 2021 the windows will be nearing the end of their lifetime and scheduled for replacement in the following years. The expenditure in 2019 has been greatly reduced to allow for an “as needed” targeted replacement of the caulking.</p>

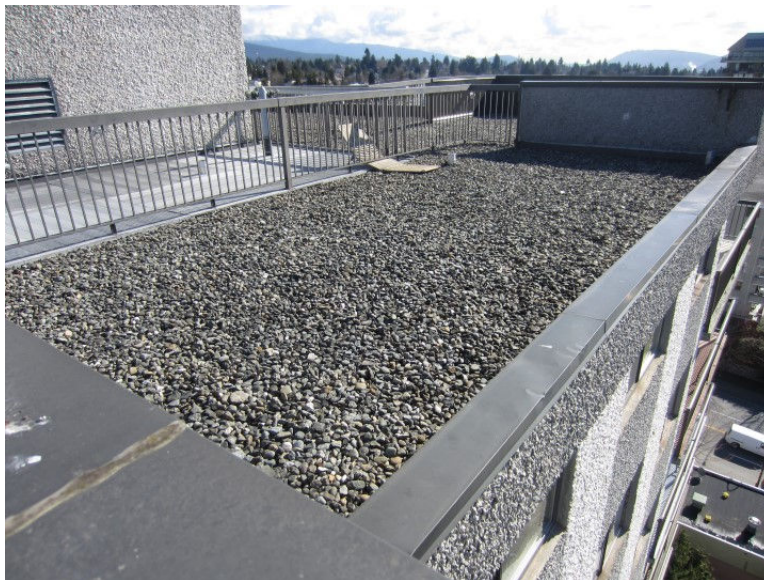
Unit Quantity	4,475 ft ²								
Unit Cost Estimate	\$30.00 / ft ²								
Current Repair or Replacement Cost Estimate	\$134,250								
Estimated Year of Major Repair or Replacement	2035								
Additional Comments	<p>The roof appears to be good construction and through proper maintenance the useful life can be extended. No deficiencies were noted.</p>

Image 22. Roof

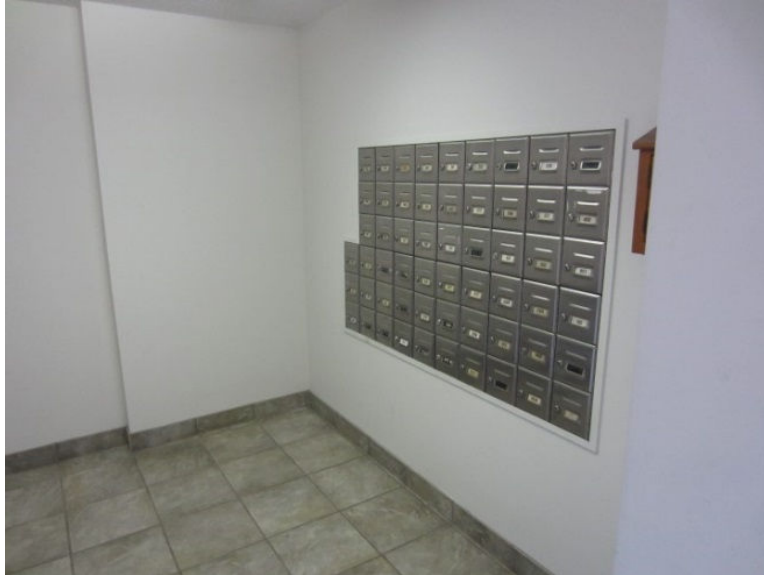
Image 26. Mail Area

Physical Description	<p>The pricing of this component includes replacement of the lobby tile, paint and furnishings.</p> <p>The lobby is a total of 1,500 ft² which houses a small mail box area and simple wall finishes. The exterior lobby wall is window and entry door.</p>	
Financial Analysis	<p>No known expenditures for the lobby.</p>	
Potential Deterioration	<p>Deterioration can include</p> <ul style="list-style-type: none"> • Misuse or vandalism • Accidental damage • Becoming outdated 	
Condition Analysis	<p>The lobby is in decent condition with only small signs of wear. The lobby tile has been well maintained and no damage was observed.</p>	
Life Cycle Analysis	Date of Acquisition	1974
	Normal Life Span	20 years
	Effective Age	5 years
	Remaining Life Span	15 years
Unit Quantity And Cost Estimates	Unit Quantity	1,500 ft ²
	Unit Cost Estimate	\$25,000
	Current Repair or Replacement Cost Estimate	\$25,000 (Allowance)

Estimated Year of Major Repair or Replacement	2029
Additional Comments	<p>Through proper maintenance the lobby has remained in great condition. There are no noted deficiencies.</p>

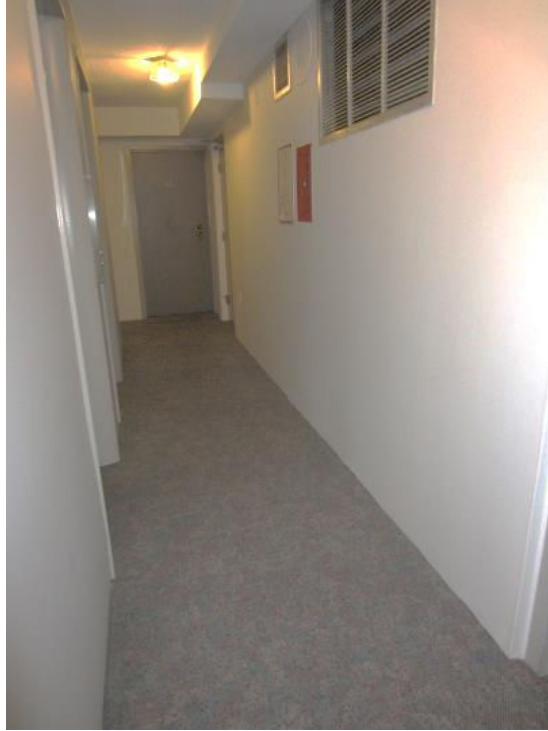
Image 30. Typical Hallway Finishes

Physical Description	The pricing of this component includes replacement of the hallway paint. The hallways have a total wall area of 2,250 ft ² . The walls are painted gypsum board with baseboard and trim.	
Financial Analysis	The expenditures for the hallway were not released.	
Potential Deterioration	Deterioration may occur in the following circumstances: <ul style="list-style-type: none"> • Misuse or vandalism • Accidental damage • Become outdated 	
Condition Analysis	The hallways walls have been well cared for with only small areas of insignificant damage. No major problems were detected and the paint appears bright.	
Life Cycle Analysis	Date of Acquisition	1974, 2013
	Normal Life Span	10 years
	Effective Age	1 years
	Remaining Life Span	9 years
Unit Quantity And Cost Estimates	Unit Quantity	3,600 ft ²
	Unit Cost Estimate	\$26,000
	Current Repair or Replacement Cost Estimate	\$26,000 (Allowance)

Estimated Year of Major Repair or Replacement	2023
Additional Comments	Through proper maintenance the hallway has remained in great condition. There are no noted deficiencies.

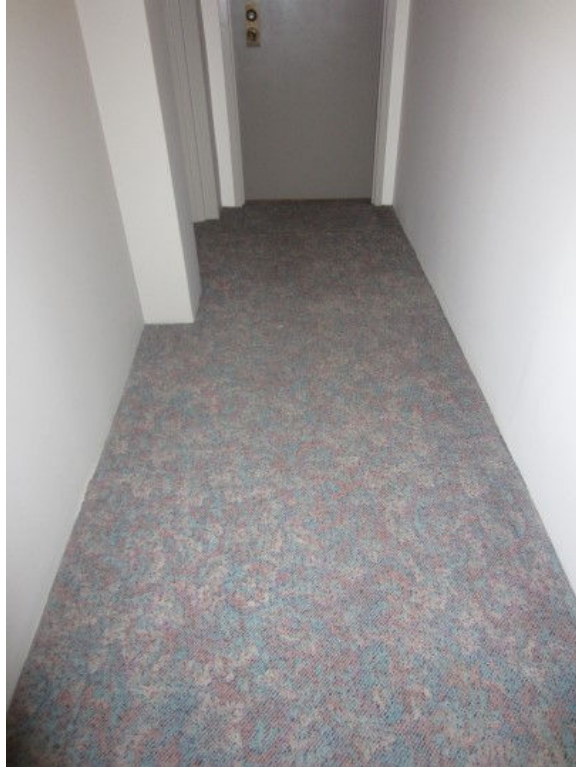
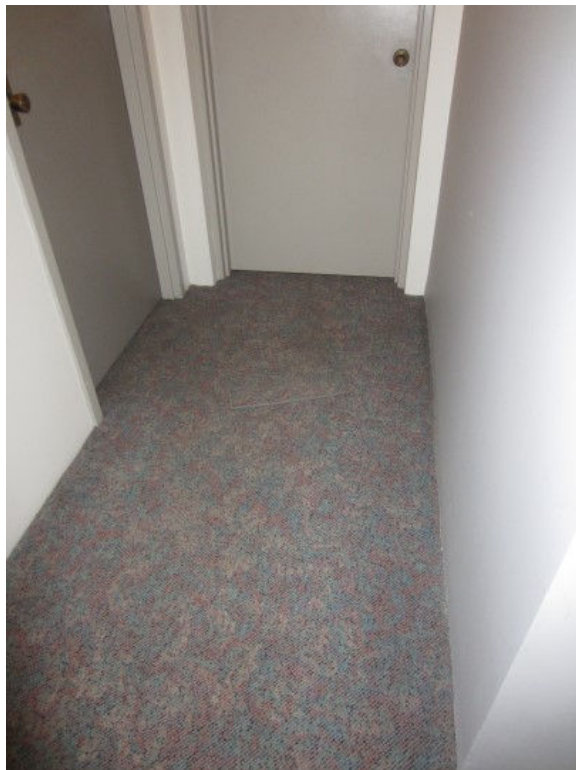
Image 32. Typical Hallway Carpet

Physical Description	The pricing of this component includes replacement of the hallway carpet. The hallways have a total floor area of 3,600 ft ² with rolled carpet throughout.	
Financial Analysis	The expenditures for the hallways were not released.	
Potential Deterioration	Deterioration may occur in the following circumstances: <ul style="list-style-type: none"> • Misuse or vandalism • Accidental damage • Become outdated 	
Condition Analysis	The hallways are in great condition with only small signs of wear and staining in the carpet.	
Life Cycle Analysis	Date of Acquisition	1974
	Normal Life Span	15 years
	Effective Age	4 years
	Remaining Life Span	11 years
Unit Quantity And Cost Estimates	Unit Quantity	3,600 ft ²
	Unit Cost Estimate	\$40,000
	Current Repair or Replacement Cost Estimate	\$40,000 (Allowance)
	Estimated Year of Major Repair or Replacement	2025
Additional Comments	Through proper maintenance the hallway has remained in great condition. There are no noted deficiencies.

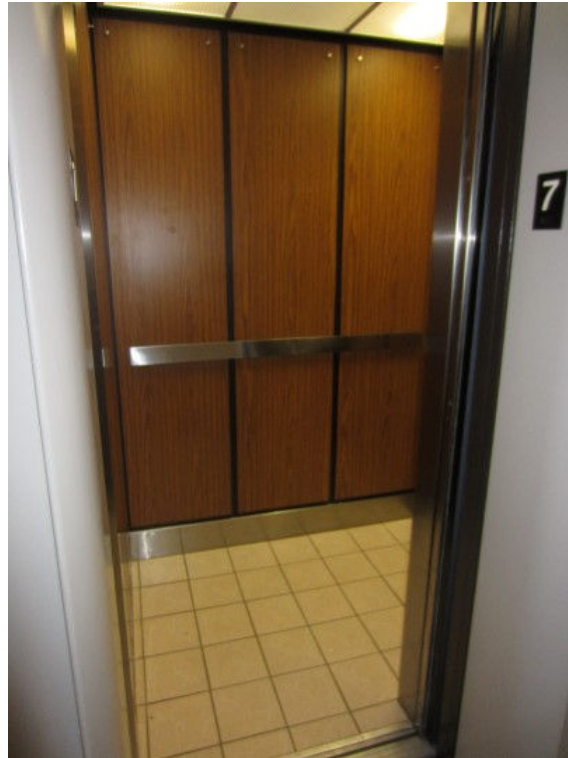
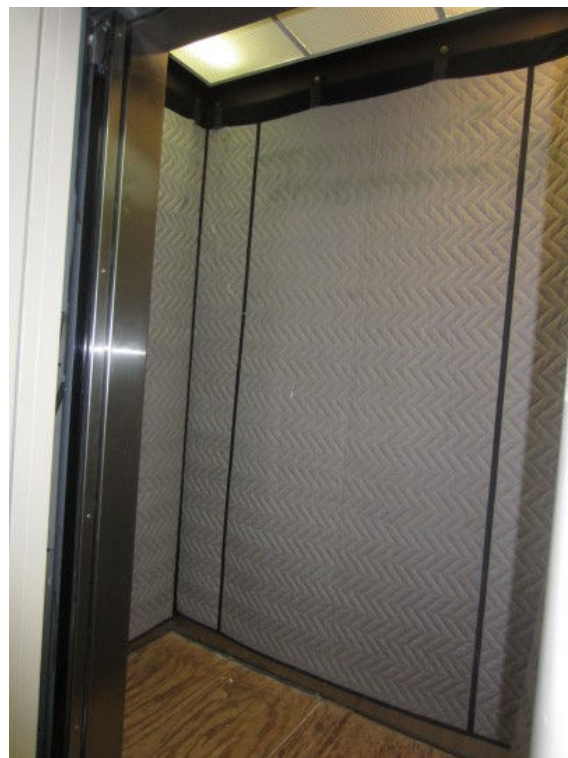
Image 34. Elevator Cab Interior

Physical Description	<p>This reserve component includes the replacement of all finishes currently in the elevator cab.</p> <p>There are decorative wood veneer wall panels with stainless steel trim and doors. The two cab differ in height, one being 9'-6" and one 8'-0".</p>	
Financial Analysis	<p>No known expenditures.</p>	
Potential Deterioration	<p>Deterioration can include</p> <ul style="list-style-type: none"> • Finishes can be damaged from tenant wear and tear, • Moving damage inflicted by tenants, • Cab interiors can become outdated 	
Condition Analysis	<p>The cab finishes were observed to be well maintained and in good condition. No wall or ceiling panels are damaged and there are no cracked or broken floor tiles.</p>	
Life Cycle Analysis	Date of Acquisition	1974
	Normal Life Span	25 years
	Effective Age	10 years
	Remaining Life Span	15 years
Unit Quantity And Cost Estimates	Unit Quantity	2 Units

Unit Cost Estimate	\$12,800 ea
	Current Repair or Replacement Cost Estimate	\$25,600
	Estimated Year of Major Repair or Replacement	2029
Additional Comments	<p>Elevator cab interior finishes tend to be very durable and last many years. As the building around the elevator is remodelled and redecorated the elevator cab may become outdated, compared with surround areas, much faster.</p> <p>No noted deficiencies.</p>

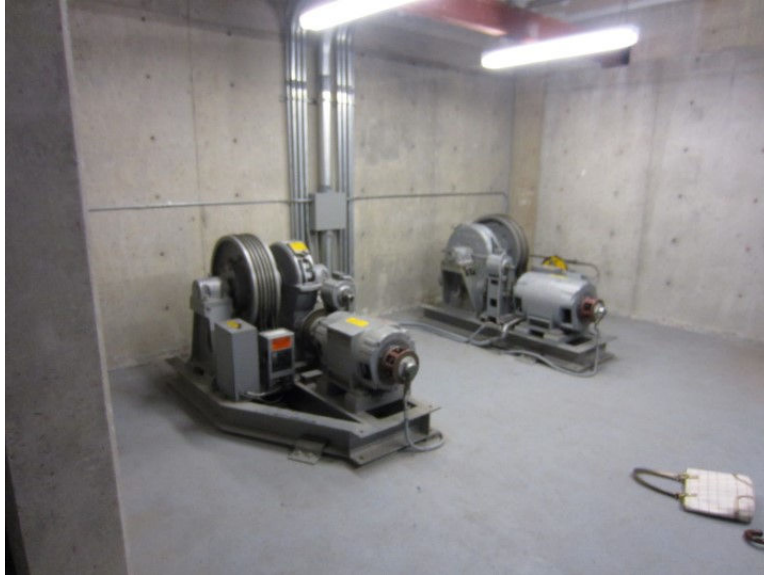
Unit Quantity	2 Elevators								
Unit Cost Estimate	\$110,000 ea.								
Current Repair or Replacement Cost Estimate	\$220,000								
Estimated Year of Major Repair or Replacement	2039								
Additional Comments	Elevator machinery is monitored and regulated thoroughly ensuring a longer lifespan. Machinery may become obsolete and need to be replaced with a new model. Laws related to elevator safety are continuously changing. A modernization may need to be completed before the end of the elevators useful life due to the governing laws.

Image 36. Traction Elevator Sheaves

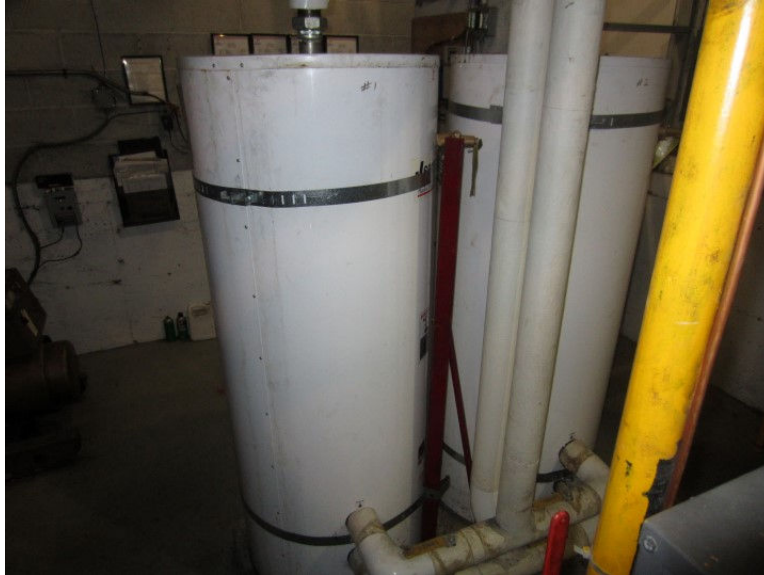
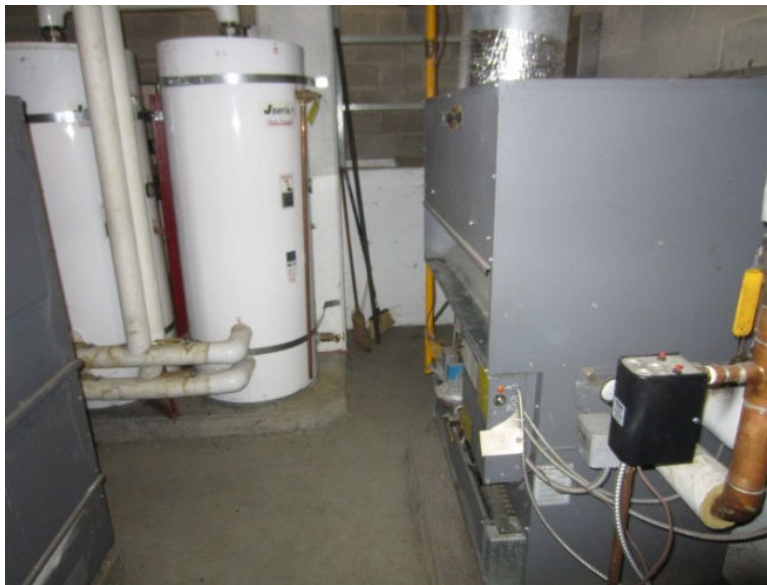
Life Cycle Analysis	Date of Acquisition	1974
	Normal Life Span	20 years
	Effective Age	12 years
	Remaining Life Span	8 years
Unit Quantity And Cost Estimates	Unit Quantity	1 System
	Unit Cost Estimate	\$38,000
	Current Repair or Replacement Cost Estimate	\$38,000 (Allowance)
	Estimated Year of Major Repair or Replacement	2022
Additional Comments	<p>An allowance has been chosen to cover the cost of the multiple plumbing components.</p> <p>Proper maintenance and regular inspections, of the equipment, will reveal any problems and allow for minor repairs to be made, extending the equipment's useful life.</p> <p>The expenditure in 2022 has been split into a multi-year project to allow for a phase approach at replacement.</p>

Image 38. Hot Water Tanks

Image 39. Boiler and Hot Water Tanks

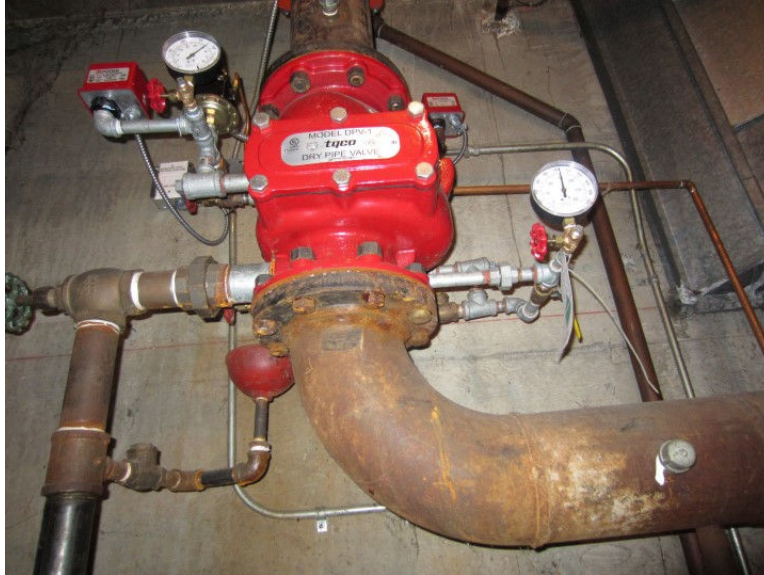
Image 40. Sprinkler Room

Physical Description	<p>The Fire Protection system consists of both a dry system involving distribution piping, risers, and sprinkler heads.</p> <p>The dry system is throughout the underground parking garage and is composed of a compressor and a 6" reliable dry valve.</p>								
Financial Analysis	<p>This component has no known expenditures.</p>								
Potential Deterioration	<p>Deterioration can include</p> <ul style="list-style-type: none"> • Corrosion of iron piping • Corrosion of sprinkler heads • Failure of fire pump driver and impeller • Failure of valve internal assemblies • Leakage and water damage to the building 								
Condition Analysis	<p>The system was observed to be in good condition. Inspections are up to date and no problems have been noted in Strata minutes.</p>								
Life Cycle Analysis	<table border="0"> <tr> <td>Date of Acquisition</td> <td>1974</td> </tr> <tr> <td>Normal Life Span</td> <td>40 years</td> </tr> <tr> <td>Effective Age</td> <td>36 years</td> </tr> <tr> <td>Remaining Life Span</td> <td>4 years</td> </tr> </table>	Date of Acquisition	1974	Normal Life Span	40 years	Effective Age	36 years	Remaining Life Span	4 years

Date of Acquisition	1974								
Normal Life Span	40 years								
Effective Age	36 years								
Remaining Life Span	4 years								
Unit Quantity And Cost Estimates	<table border="0"> <tr> <td>Unit Quantity</td> <td>1 Unit</td> </tr> <tr> <td>Unit Cost Estimate</td> <td>\$8,000</td> </tr> <tr> <td>Current Repair or Replacement Cost Estimate</td> <td>\$8,000 (Allowance)</td> </tr> <tr> <td>Estimated Year of Major Repair or Replacement</td> <td>2018</td> </tr> </table>	Unit Quantity	1 Unit	Unit Cost Estimate	\$8,000	Current Repair or Replacement Cost Estimate	\$8,000 (Allowance)	Estimated Year of Major Repair or Replacement	2018
Unit Quantity	1 Unit								
Unit Cost Estimate	\$8,000								
Current Repair or Replacement Cost Estimate	\$8,000 (Allowance)								
Estimated Year of Major Repair or Replacement	2018								
Additional Comments	<p>If a flushing investigation has not been undertaken in the past, it is recommended that this be completed. This will provide Strata with details on the condition of the pipes which fall outside the scope of this report.</p>

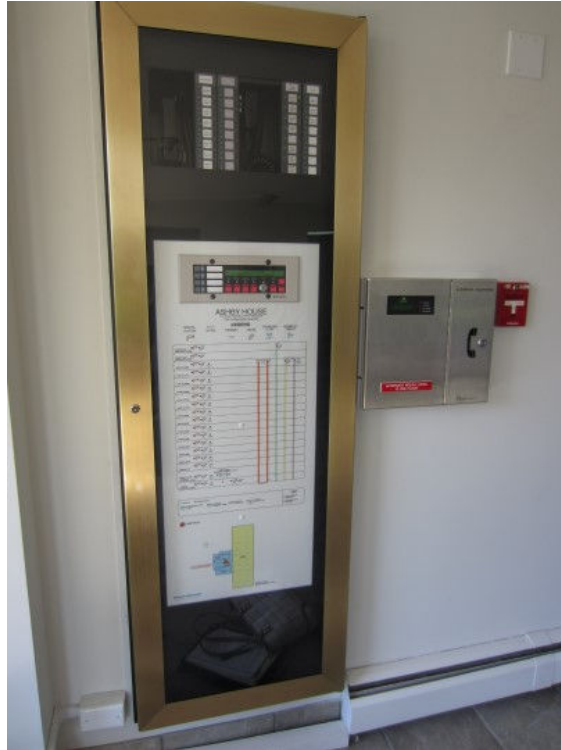
Life Cycle Analysis	Date of Acquisition	1974, 2013
	Normal Life Span	20 years
	Effective Age	1 year
	Remaining Life Span	19 years
Unit Quantity And Cost Estimates	Unit Quantity	1 Unit
	Unit Cost Estimate	\$75,000
	Current Repair or Replacement Cost Estimate	\$75,000 (Allowance)
	Estimated Year of Major Repair or Replacement	2033
Additional Comments	<p>A project of this size should not need to be undertaken again if continuous maintenance and replacement of end devices are completed.</p>

Image 42. Fire Alarm Display Panel

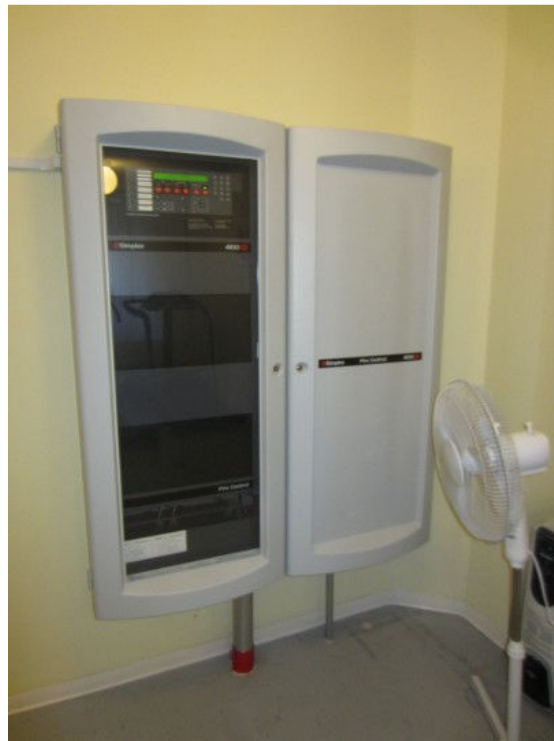
Image 43. Fire Alarm Panel

The Ashby House is a concrete high rise built in 1974. The fire alarm system, including panel, has been modernized and is now code compliant to 2013 standards. The exterior envelope is original with aluminum, single glazed windows and sliding glass doors. There is a leak in the upper level of the garage which may be a signal of a garage membrane leak. In 2013 the floor lateral piping was replaced. The tower water riser has shown signs of deterioration and is scheduled for replacement in the next few years.

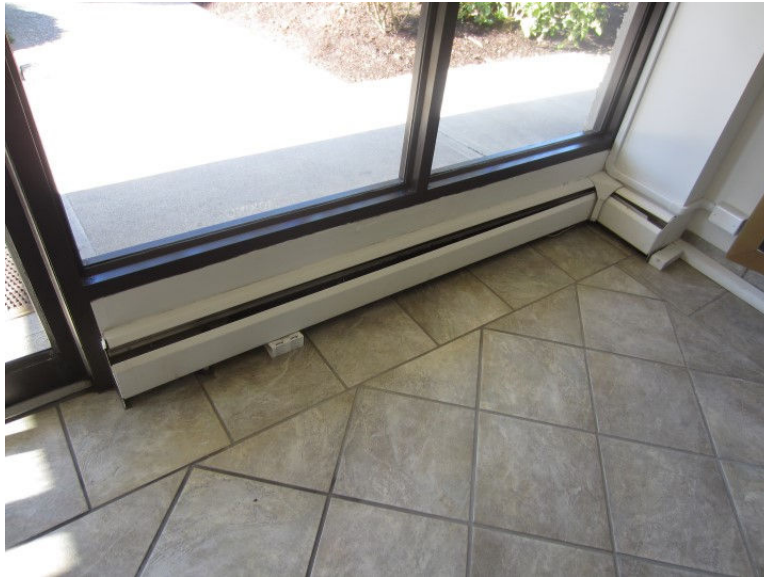
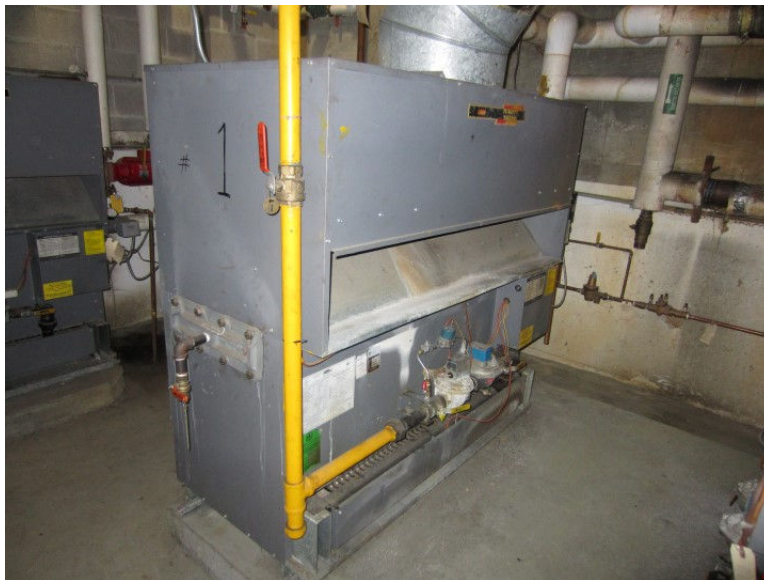
Life Cycle Analysis	Date of Acquisition	1974
	Normal Life Span	20 years
	Effective Age	7 years
	Remaining Life Span	13 years
Unit Quantity And Cost Estimates	Unit Quantity	1 unit
	Unit Cost Estimate	\$65,000
	Current Repair or Replacement Cost Estimate	\$65,000 (Allowance)
	Estimated Year of Major Repair or Replacement	2027
Additional Comments	The boilers have had an overhaul in the last year which has modernized them to run more efficiently. Since this time, the boilers have been operating at a much more efficient rate and are provide more than adequate heat.	
	The expenditure in 2027 has been split into a multi-year phased replacement with the following expenditure in 2032.

Image 44. Baseboard Unit

Image 45. Natural Gas Boiler

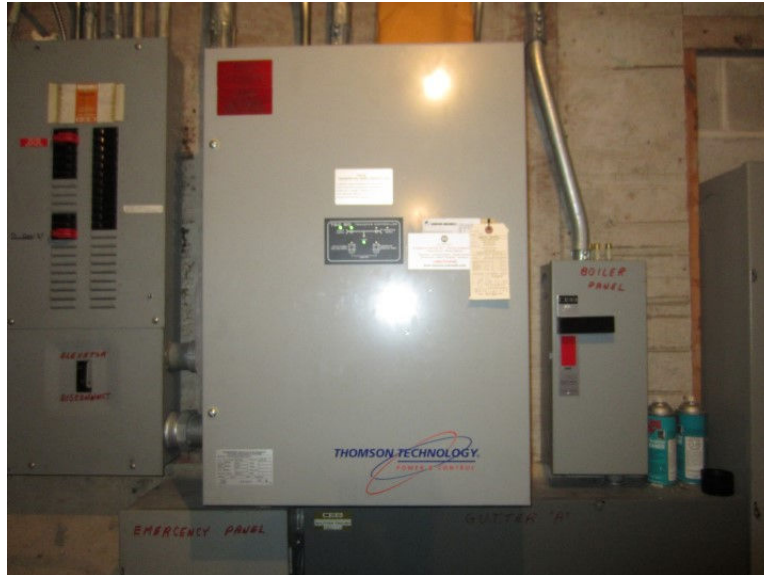
Image 46. Electrical Room

Physical Description	This reserve includes the incoming electrical service, various distribution panels, and electrical fixtures.	
Financial Analysis	No known expenditures have been made to any of the electrical equipment	
Potential Deterioration	Deterioration can include <ul style="list-style-type: none"> • Electrical component failures • Degradation of mechanical components • Contamination due to dust, moisture • Vandalism or misuse 	
Condition Analysis	The electrical room was in clean and dry condition with no excess build-up of dust on any of the equipment. Electrical distribution cannot be inspected and is beyond the scope of this report. The parking garage lighting is original to the building and some Strata has considered upgrading to energy efficient fixtures.	
Life Cycle Analysis	Date of Acquisition	1974
	Normal Life Span	25 years
	Effective Age	20 years
	Remaining Life Span	5 years
Unit Quantity And Cost Estimates	Unit Quantity	1 Unit

Unit Cost Estimate	\$8,000
	Current Repair or Replacement Cost Estimate	\$8,000 (Allowance)
	Estimated Year of Major Repair or Replacement	2019
Additional Comments	Strata may want to explore their options of replacing the underground parking fixtures with an energy efficient model.

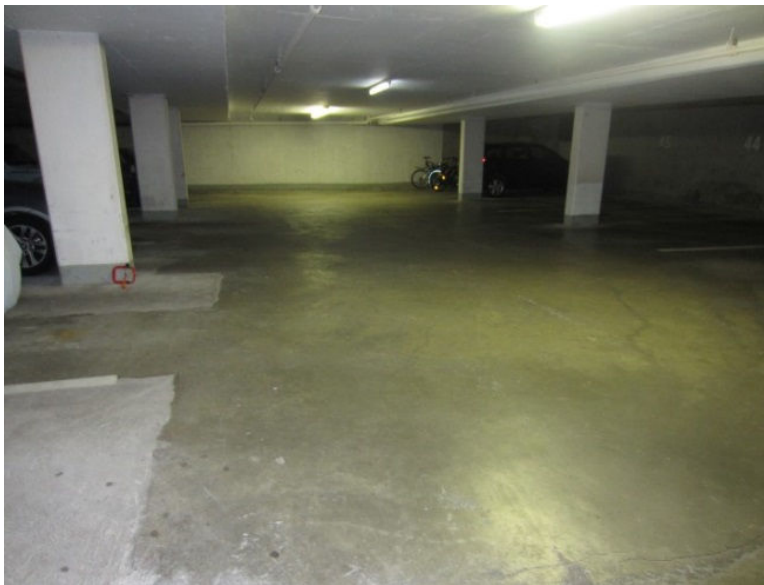
Image 47. Underground Garage Fixtures

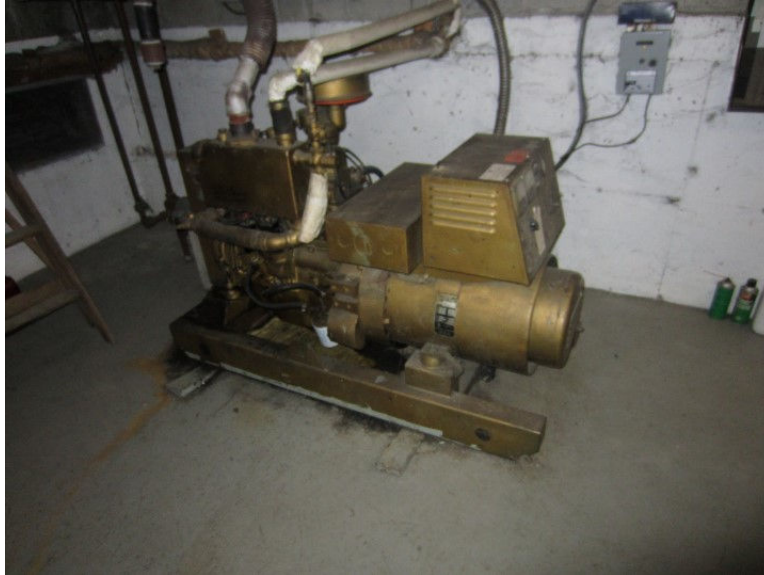
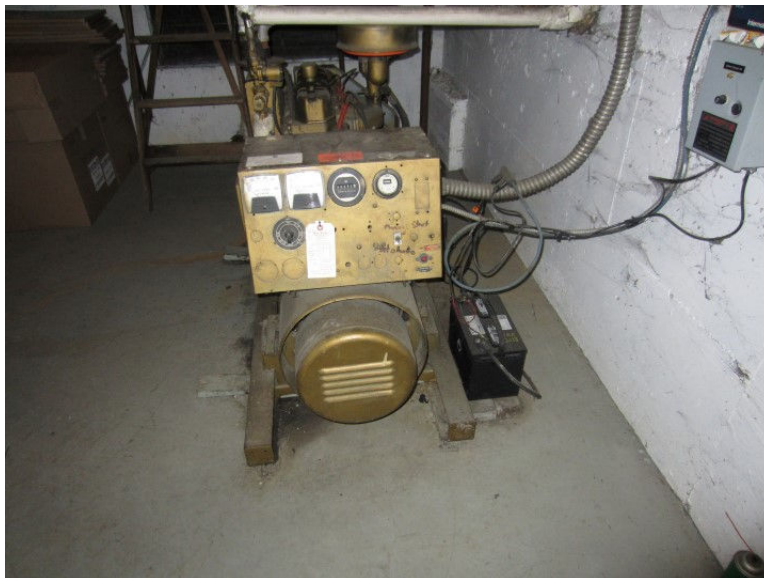
Unit Quantity And Cost Estimates	Unit Quantity	1 Unit
	Unit Cost Estimate	\$28,000
	Current Repair or Replacement Cost Estimate	\$28,000 (Allowance)
	Estimated Year of Major Repair or Replacement	2020
Additional Comments	<p>The replacement of the generator may be suggested to Strata by the maintenance contractors. Aging machinery can become costly to repair and maintain and eventually can be deemed obsolete. It is recommended, that as failures begin to occur, Strata consider replacement before costly repairs are undertaken.</p> <p>When a new generator is installed Strata may consider replacing with a larger unit. The current generator is 25 kW and the pricing, in this component, is for a generator of this size.</p>

Image 48. Emergency Generator

Image 49. Emergency Generator

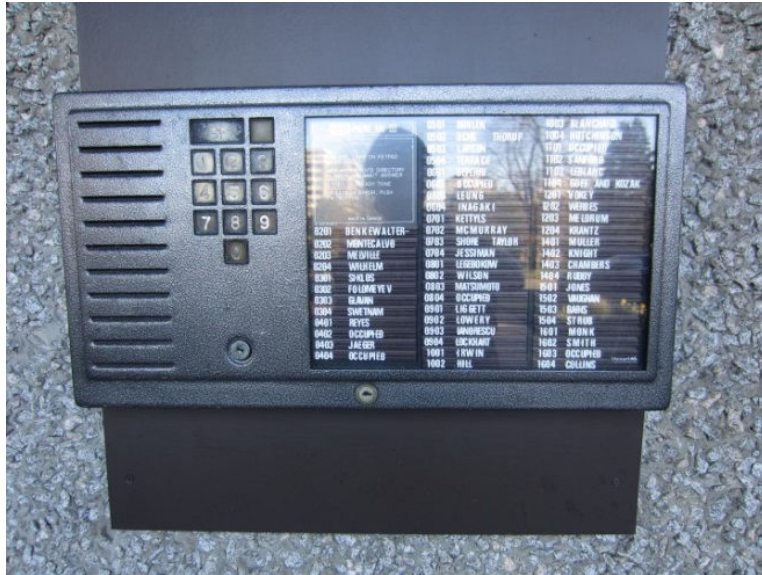
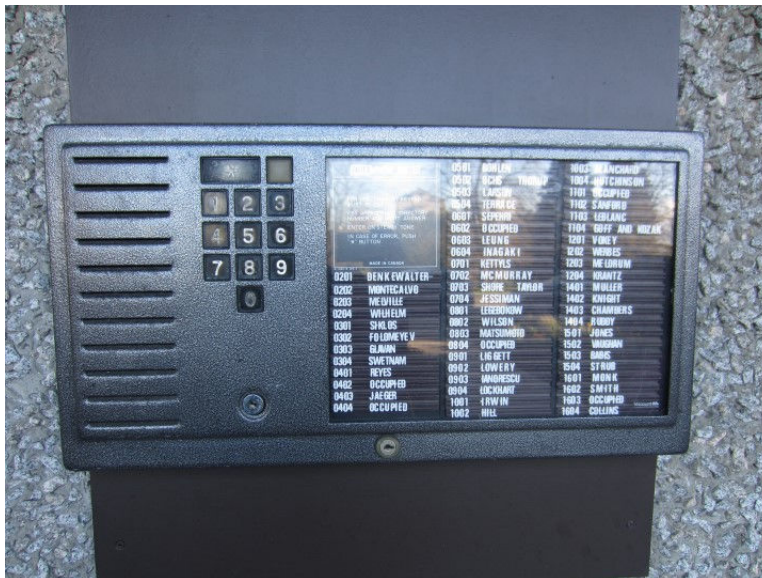
Remaining Life Span	8 years
Unit Quantity And Cost Estimates	Unit Quantity	1 System
	Unit Cost Estimate	\$9,000
	Current Repair or Replacement Cost Estimate	\$9,000
	Estimated Year of Major Repair or Replacement	(Allowance) 2022
Additional Comments	<p>An allowance has been chosen to cover the cost of the multiple access control and site security components.</p> <p>Dated security infrastructure can lead to tenant desire for more up to date and modern building security features.</p>

Image 50. Enterphone System

Image 51. Enterphone System
