Date Delivered September 08, 2017 10:48AM
Strata Manager Assertive Northwest Property Management Group Inc.
eStrataHub Order Number 191192
Folio Reference 1401-114 W Keit
Requestor Company Remax
Requested By Jim Williamson
Property Name Ashby House
Strata Plan # VAS145
Strata Lot # 45
Civic Address 1401-114 KEITH ROAD

eSH191192-03-Depreciation Report_VR-0145 - Depreciation Report FINAL(133).pdf

Document: Warranty
Property: Ashby House
Strata Plan #: VAS145
Strata Lot #: 45
Comment: The document you requested is not available for this property.

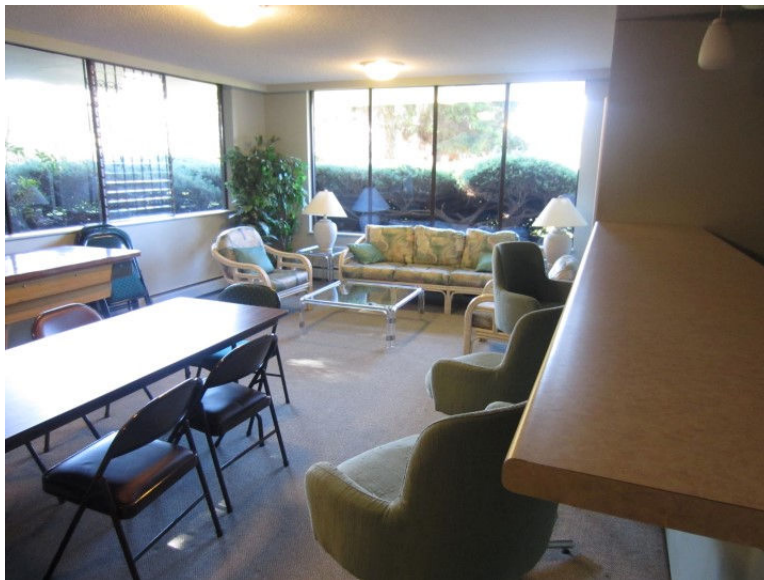
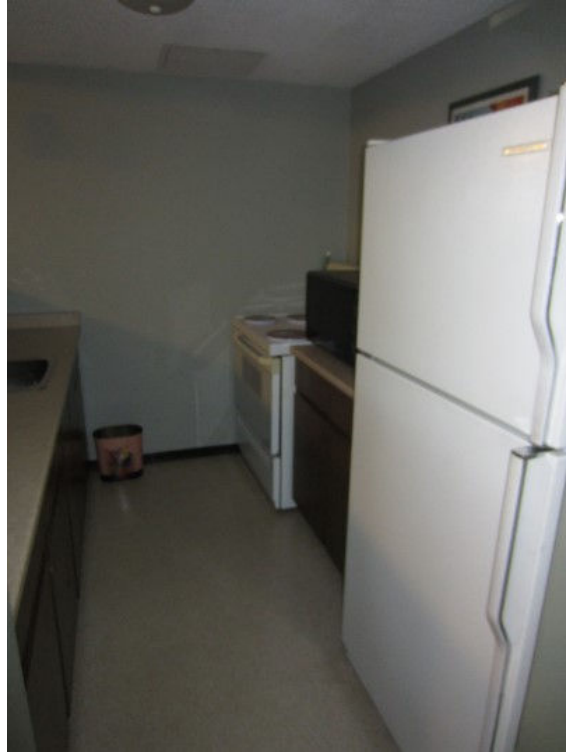
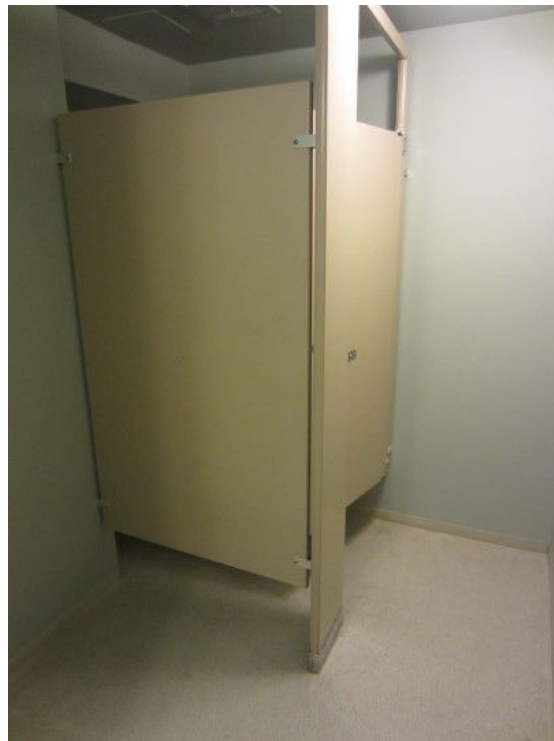
Physical Description	<p>This component reserves for the carpet and paint replacement of the community room. An allowance has been included for the targeted repair of the kitchenette and bathroom and replacement of the existing furniture.</p> <p>The community room is 650 ft² which includes a small kitchen and a 2 piece bathroom. The room has rolled carpet with painted gypsum board walls. There is a pool table, shuffle board table and living room furniture.</p>	
Financial Analysis	<p>No known expenditures.</p>	
Potential Deterioration	<p>Deterioration may occur in the following circumstances:</p> <ul style="list-style-type: none"> • Misuse or vandalism • Accidental damage • Equipment wear and tear • Mechanical and electrical failure • Water leakage • Become outdated • Deterioration from heat, moisture or mildew 	
Condition Analysis	<p>The community room is in good condition. The bathroom and kitchen appear to be original and are beginning to become dated. The condition of the community room is good, and unless Strata would like to give it a new look, renovation is not mandatory.</p>

Image 53. Community Room

Image 54. Community Room Kitchen Area

Image 55. Community Room Bathroom

Life Cycle Analysis	Date of Acquisition	1974
	Normal Life Span	15 years
	Effective Age	2 years
	Remaining Life Span	13 years
Unit Quantity And Cost Estimates	Unit Quantity	1 Room
	Unit Cost Estimate	\$16,000
	Current Repair or Replacement Cost Estimate	\$16,000 (Allowance)
	Estimated Year of Major Repair or Replacement	2027
Additional Comments	<p>The Strata can choose to update this room as funds become available. Due to recent expenditures the renewal of the amenity rooms is not viable. The aesthetics do not hinder the functionality of the spaces, and therefore the expenditures have been pushed back to 2029 after the major projects.</p>

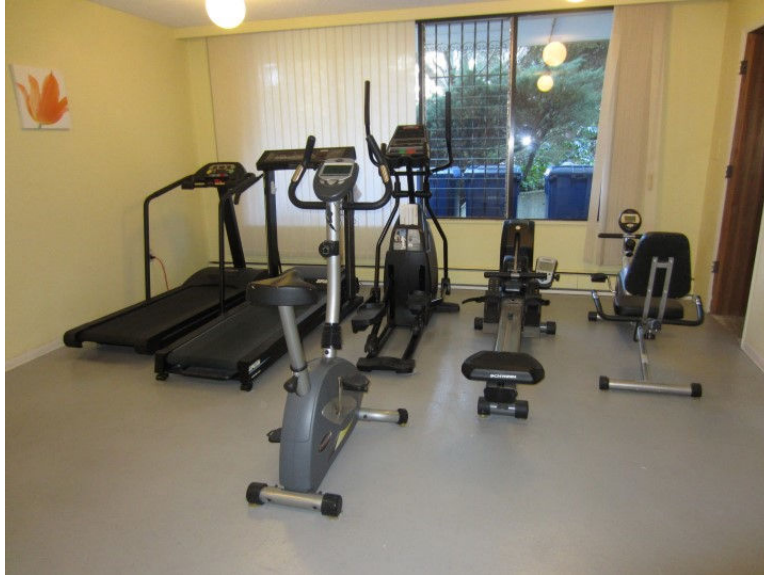
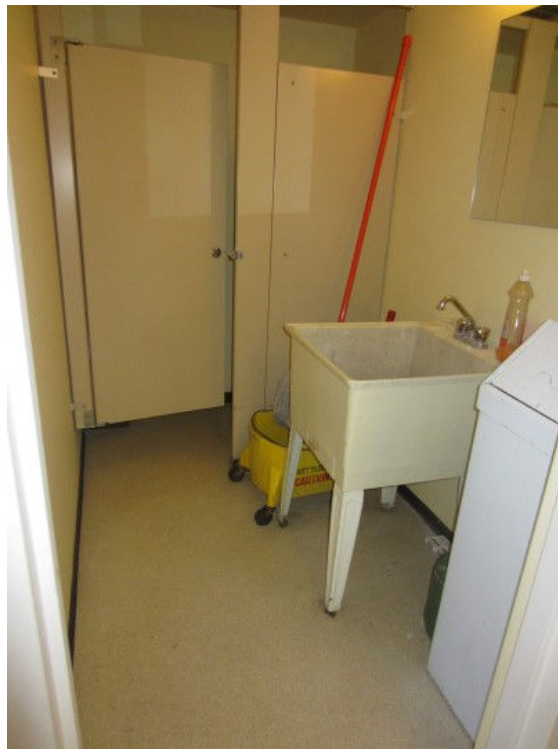
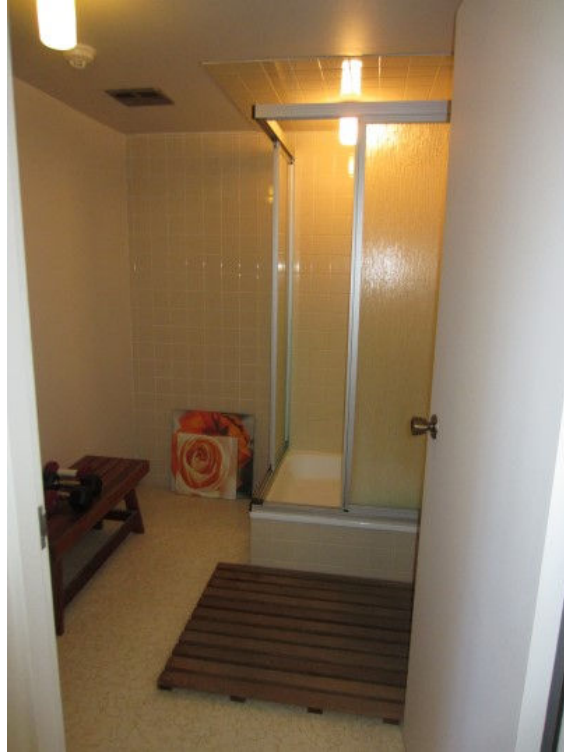
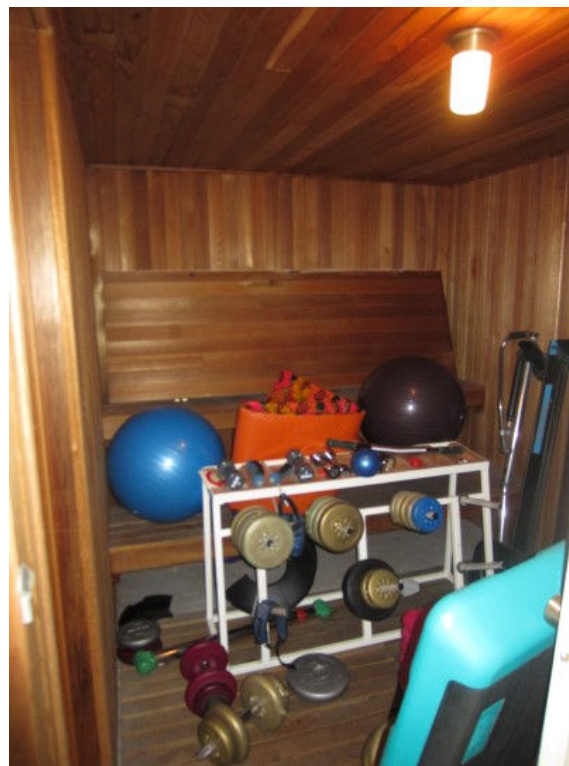
Physical Description	<p>This component reserves for the painting of the floor and an allowance to upgrade the shower and bathroom. It has been assumed that the sauna, as it is being used as storage, is not being used and no money has been set aside for the repair or replacement.</p> <p>The exercise room is 700 ft² which including the bathroom, shower and sauna. The exercise equipment has all been donated by tenants and this component does not reserve for any replacement.</p>	
Financial Analysis	No known expenditures.	
Potential Deterioration	<p>Deterioration may occur in the following circumstances:</p> <ul style="list-style-type: none"> • Misuse or vandalism • Accidental damage • Equipment wear and tear • Mechanical and electrical failure • Water leakage • Become outdated • Deterioration from heat, moisture or mildew 	
Condition Analysis	The exercise room is in good condition. The wall paint appears bright and fresh and the floor is in good condition. The bathroom and shower are dated but it appears that they are also seldom used.

Image 56. Exercise Area

Image 57. Bathroom

Image 58. Shower Room

Image 59. Sauna

Life Cycle Analysis	Date of Acquisition	1974
	Normal Life Span	15 years
	Effective Age	6 years
	Remaining Life Span	9 years
Unit Quantity And Cost Estimates	Unit Quantity	1 Room
	Unit Cost Estimate	\$7,500
	Current Repair or Replacement Cost Estimate	\$7,500 (Allowance)
	Estimated Year of Major Repair or Replacement	2023
Additional Comments	<p>This component has not included a total renovation of the bathroom, shower and sauna. It appears that they are seldom used and it is unlikely that Strata would substantially renovate these. An allowance has been added for the “refresh” including paint and flooring. If Council would like complete replacement of tile, shower and toilet stall, and fixtures, in these rooms included please advise the planner and the pricing will be amended. The aesthetics do not hinder the functionality of the spaces, and therefore the expenditures have been pushed back to 2030 after the major projects.</p>
